RESEARCH AND EDUCATION

Survival of extensively damaged endodontically treated incisors restored with different types of posts-and-core foundation restoration material

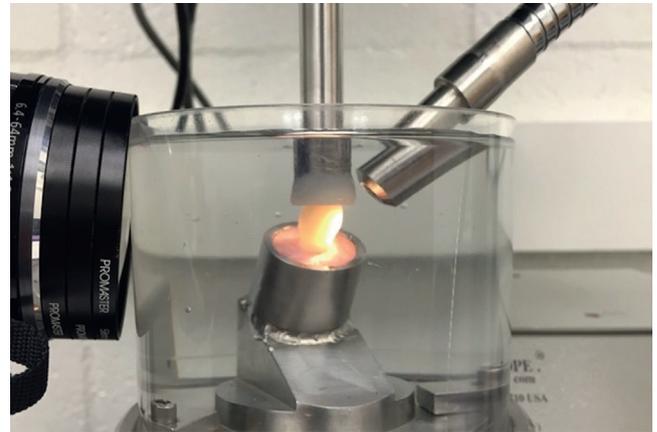
Figure 4. Specimen in load chamber. Macro camera and transillumination light used to identify crack propagation mode (initial and final failures).

propagation mode (initial gap and final failure) (Fig. 4). The number of cycles endured and the failure mode of each specimen were recorded. After the test, each specimen was evaluated by transillumination (Microlux; AdDent, Inc) and optical microscopy (Leica MZ 125; Leica Microsystems GmbH) at $\times 10$ magnification. A visual distinction was made among 3 fracture modes, considering the reparability of the tooth: catastrophic (root fracture that would require extraction); possibly repairable (cohesive/adhesive failure with fragment and minor damage of root structure); or repairable fracture (cohesive or adhesive failure of restoration only).

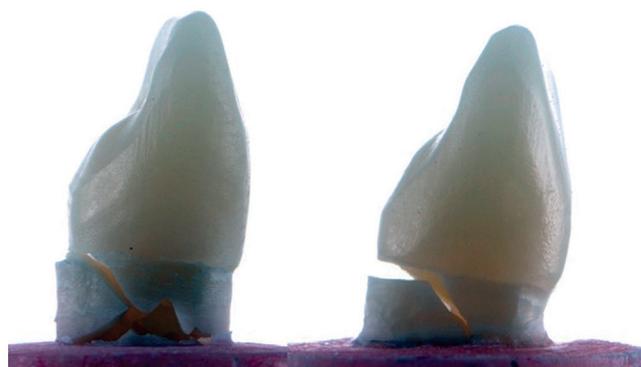
Figure 7. All specimens were classified as catastrophic (tooth/root fracture that would require tooth extraction).

Failure mode analysis showed 100% of catastrophic failures (crack vertically propagated in the cervical and middle portions of the root) (Fig. 7).
