# Porcelain veneer post-bonding crack repair by resin infiltration

*(Int J Esthet Dent 2017;12:156–170)*

The present case report describes the application of direct composite restorations and a thin porcelain laminate veneer. After 2 weeks, a crack was visible in the laminate veneer. This veneer was not replaced, but repaired using a step-by-step protocol.

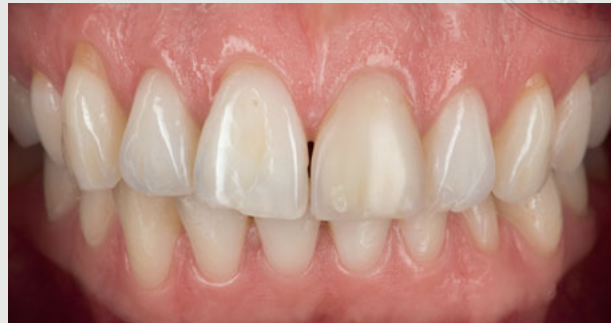
**Fig 1** Intraoral anterior view of teeth before treatment.

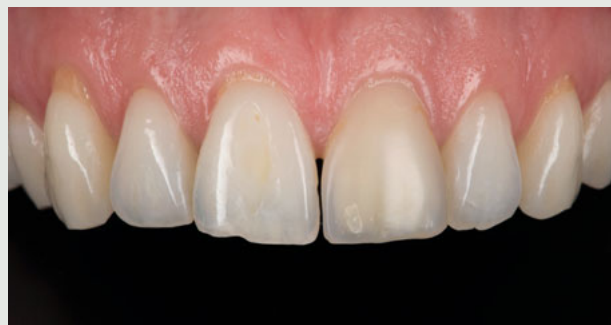
**Fig 2** Intraoral anterior view of maxillary teeth before treatment.

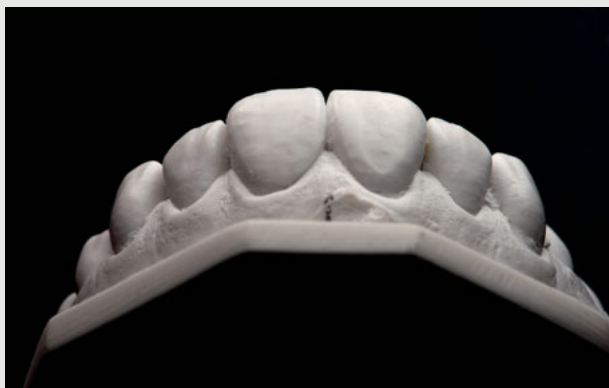
**Fig 3** Wax-up of model before treatment.

After analysis and treatment planning using a digital workflow, the patient was informed of the different possibilities using minimally invasive treatment modalities. Digital planning, wax-up (Fig 3), and mock-up placement in the mouth (Fig 4) made it possible to predictably inform the patient about form, function, and esthetic appearance.<sup>17</sup> Once the patient was informed about

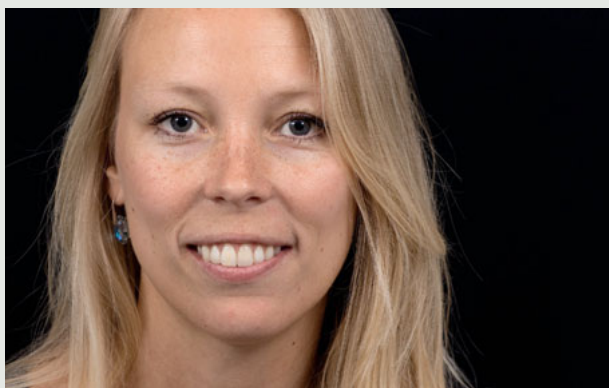
**Fig 4** Patient's smile with the mock-up.

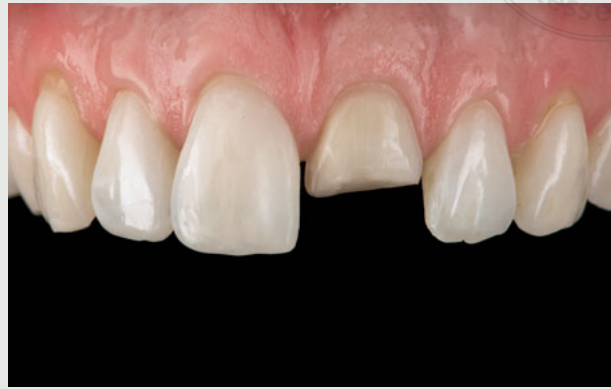
**Fig 5** Preparation of tooth 21, and direct composite restorations made on teeth 12 and 11.

nate veneer (Fig 5). Uniform preparation of the buccal surface is not preferred, as enamel thickness is varying in the buccal region of the incisors.<sup>23</sup> Therefore, standard depth cutting burs are not advised for laminate veneer preparation.<sup>22</sup> In this case, we only had to remove the composite restoration to gain sufficient space (0.3 in the cervical region, and 0.5 to 0.7 in the buccal region) for the ceramic laminate veneer.

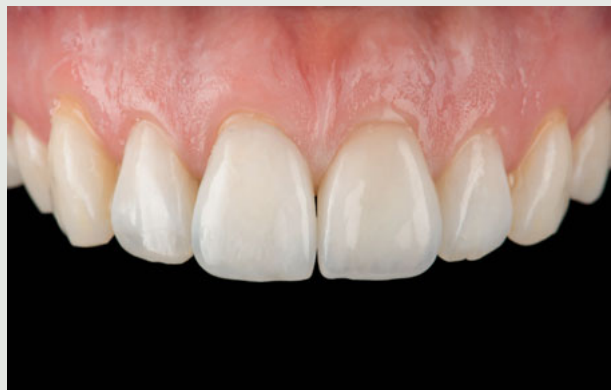
**Fig 6** Try-in of the ceramic laminate veneer. Note the blanching of the gingiva on the mesial aspect.

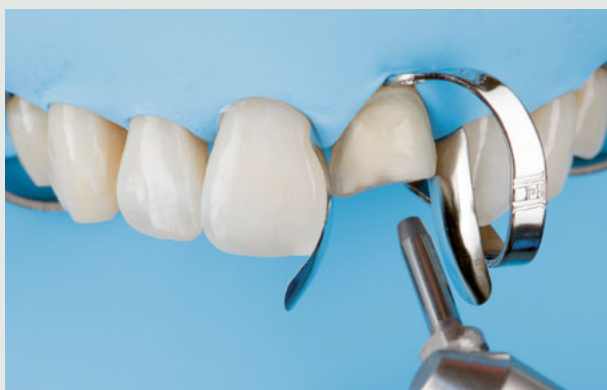
**Fig 7** Silica coating of the existing composite restoration.

There are two different substrates on the substrate side: enamel, and an existing composite restoration. After rubber dam (Isodam Non Latex Heavy, Sigma Dental Systems) and protecting matrices application, the composite surface was first silica coated using CoJet sand (3M ESPE) (Fig 7). Using silica coating and silanization (Espe Sil, 3M ESPE) for conditioning the existing composite, it is possible to achieve an acceptable and

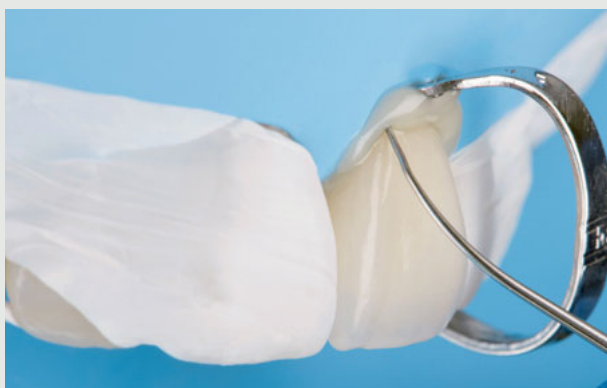
**Fig 8** Removal of the excess composite material.

Adhesive luting was facilitated using the reference of the adjacent teeth and a direct composite resin restorative as a “cement” (handling and adhesive properties). Therefore, a microhybrid resin composite (Enamel HFO UD1, Micerium) was used (Fig 8).<sup>44</sup> However, when using a direct composite resin as a luting cement, the thickness of the material can have a relevant influence on the stress distribution in the porcelain veneers. In a finite element analysis, Magne et al<sup>28</sup> concluded that laminate veneers that were thin and had a poor internal fit resulted in higher stresses at both the interface of the restoration and on the surface. This could lead to post-bonding cracks in thin laminate veneers. Therefore, it is advised that the ceramic must be more than three times the thickness of the resin composite cement. In order to prevent a thick cement interface in this case, we heated the resin composite to 55°C in an oven (Ena Heat, Micerium) to obtain a material that would be as thin under pressure as luting cement.

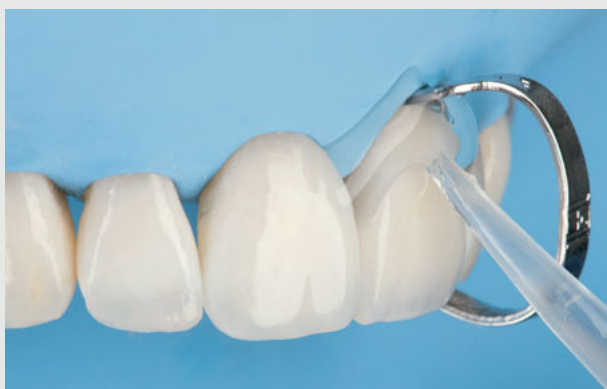
**Fig 9** Glycerin application before photopolymerization.

Using composite as a cement allowed total control of the seating of the restoration. Moreover, due to the viscosity of the composite, the excess cement could be easily removed. After the removal of the excess cement, glycerine gel (KY Gel, Johnson & Johnson) was applied at the margins to prevent an oxygen inhibition layer. Total photopolymerization (Bluephase 20i, Ivoclar Vivadent) was then performed (Fig 9). Finishing of the margins was performed using a 12D scalpel, and polishing was done using ceramic polishers (CeraGloss, Edenta). One week after delivery, the patient was seen for evaluation and final pictures (Fig 10).

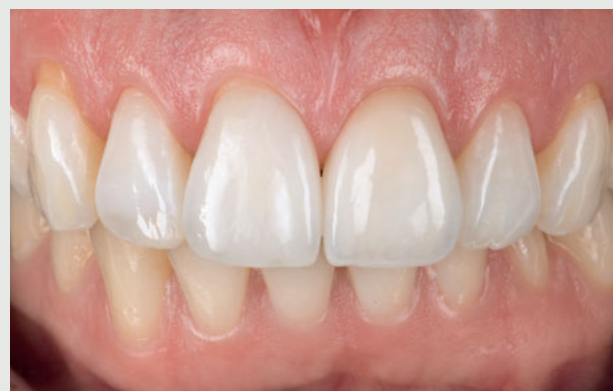
**Fig 10** Final result after adhesive luting of the laminate veneer.

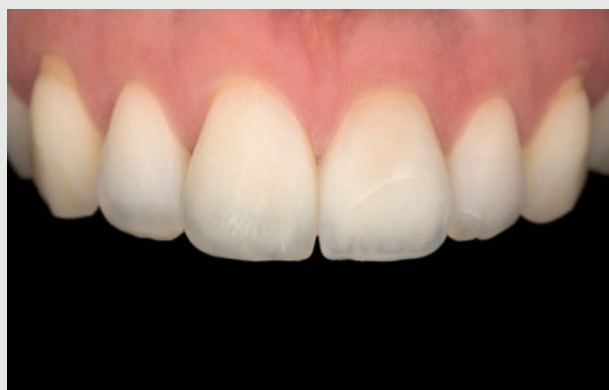
Two weeks after delivery, the patient called the clinic to report a crack on the buccal aspect of the indirect laminate veneer. At the subsequent appointment, a crack line was seen on the buccal aspect of the indirect veneer, with minimal access on the mesial aspect. The patient was evaluated, and photographs were taken using cross-polarized light (polar\_

**Fig 11** Cross-polarized photograph 2 weeks after delivery. Note the fracture on the buccal surface.

eyes, Bio-Emulation) and transmitting ultraviolet (UV) light (Figs 11 and 12). This crack in the ceramic could have been caused by preparation or delivery errors, laminate veneer fabrication errors, or patient-related factors. Since ceramics are brittle, the presence of unfilled areas may decrease their mechanical strength by two main mechanisms: 1) the sharp geometry of the unfilled channels may create spots for stress concentration; and 2) the fragile void area underneath the cement–ceramic margin may concentrate stress when submitted to mechanical loading (Fig 13).

None of the authors of this article saw any flaws in the cementation procedure or materials used for delivery of the ceramic laminate veneer, which was produced and fired according the manufacturer's instructions. Furthermore, the patient did not hear the laminate veneer fracturing, nor could she relate the fracture to any incident during the previous 2 weeks. It was concluded, therefore, that it was an internal stress-releasing crack, probably caused by the transition from thick to thin ceramic. This was concluded after combining the preparation and delivered laminate veneer images, where it was seen that the fracture was on the border of the preparation to the incisal covering part.

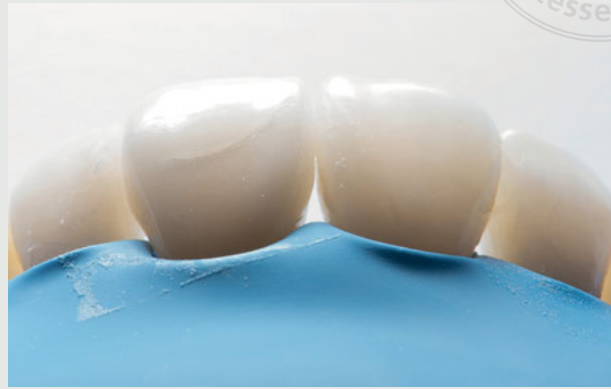
**Fig 15** Opening of the fracture after sandblasting.

Before beginning the repair procedures, a rubber dam (Isodam) was placed from first premolar to first premolar. The crack was sandblasted using 30  $\mu$ m silica-coated alumina oxide sand (CoJet) (5 to 10 s, 2 bar, 90-degree angle). The laminate veneer was protected using adhesive tape to only expose and open the crack (Figs 14 and 15). The crack was then etched using hydrofluoric acid (9% Porcelain Etch) for 90 s. Thorough rinsing with copious amounts of water was performed. A silane (Monobond Plus)

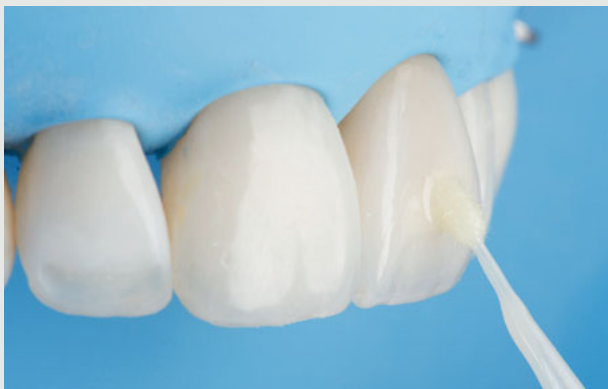
**Fig 16** Infiltration of the fracture using a filled adhesive.

was used to make the ceramic surface hydrophobic, and to promote the bond between the “silica-based” particles. The adhesive (Optibond FL) was then applied. Before placing the adhesive, the silane was heated using a curing light (twice, for 20 s), thereby turning the hydrophilic surface of the ceramic into a hydrophobic surface, better able

to absorb the resin for infiltration.<sup>45</sup> The adhesive was preheated (55°C in Ena Heat, or 68°C in Calset) and left to infiltrate for 20 min with a piece of black tape over the crack so that no light was able to polymerize the adhesive before infiltration (Fig 16). After 20 min of infiltration, a cross-polarized photograph was taken to evaluate the infiltration. Excess was then removed, and the adhesive photopolymerized for 40 s. Then, a direct resin composite was used where the opening of the buccal surface was performed, as highly filled composite resins are less prone to discoloration than flowables or adhesives. The composite was adapted using flat modelling brushes (Gradia Lab Brush, GC), and glycerin applied and photopolymerized for 40 s from two sides. The restoration was finished and polished using silicon points, goat hair and felt wheels, using 3 and 1  $\mu$ m diamond paste and alumina oxide paste (Enamel Plus Shiny, Micerium) (Fig 17) (Table 1).

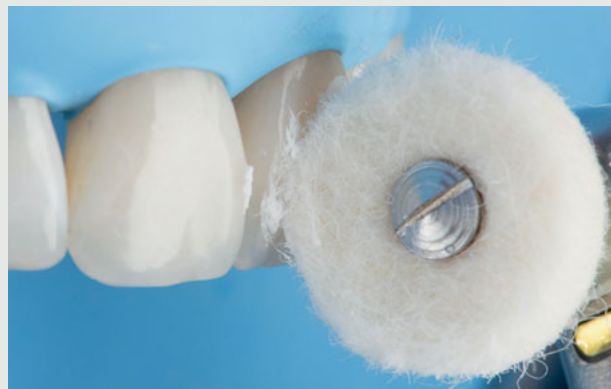
**Fig 17** Polishing of the repaired fracture.

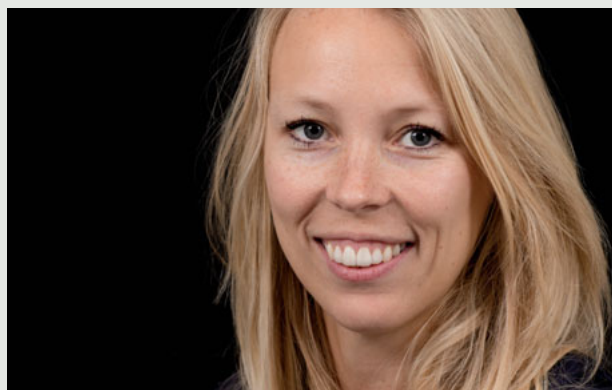
**Fig 18** Extraoral view of the patient after treatment.

The patient was satisfied with the final result and will be monitored for a longer duration (Figs 18 to 20). An additional case with a successful outcome after 2 years is also presented in Figures 21 to 25.

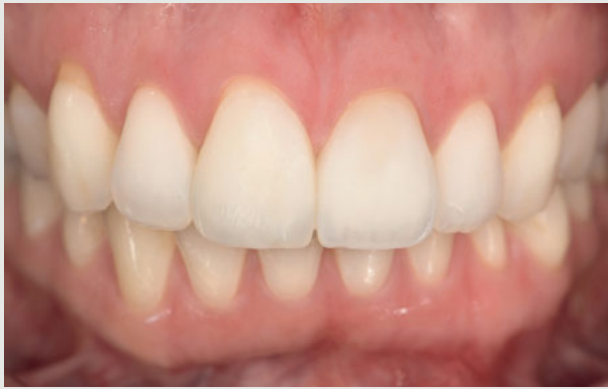
**Fig 19** Cross-polarized photograph of the laminate veneer after repair.

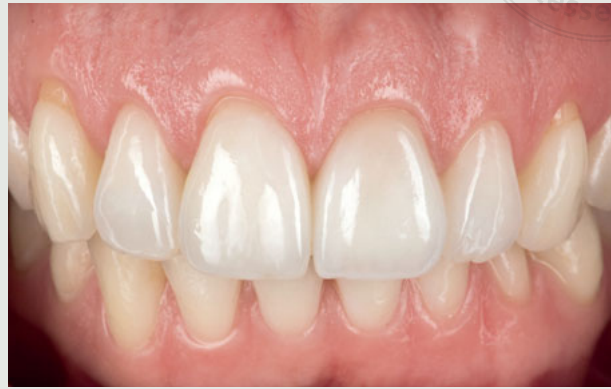
**Fig 20** Intraoral view of the repaired laminate veneer.

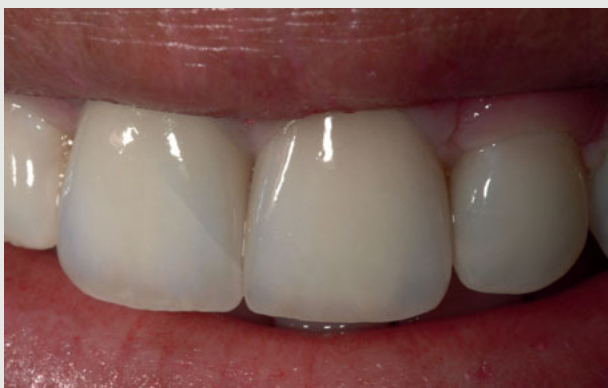
**Fig 21** Bonded porcelain crown that fractured 5 years post-placement. Original restorations (bonded crown on right central, and porcelain veneer on left central) were not made by the authors.

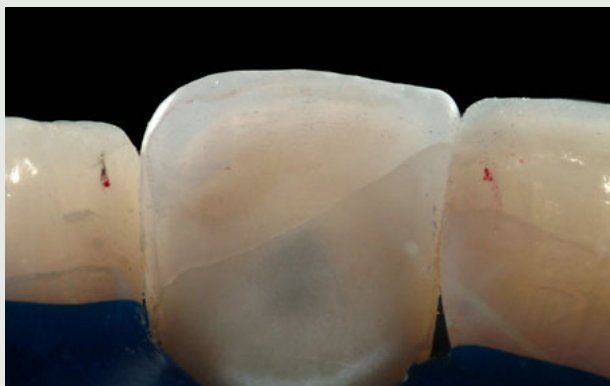
**Fig 23** Lingual view following airborne particle abrasion of cracked surface. Note similar crack in lingual enamel of neighboring teeth. Application of silane and resin infiltration were achieved from the lingual side only (labial surface was left intact).

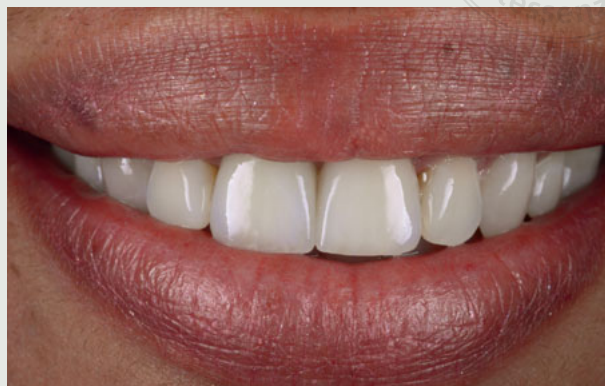
**Fig 24** Two-year postoperative view showing successful crack infiltration that saved the patient the cost of a new restoration.

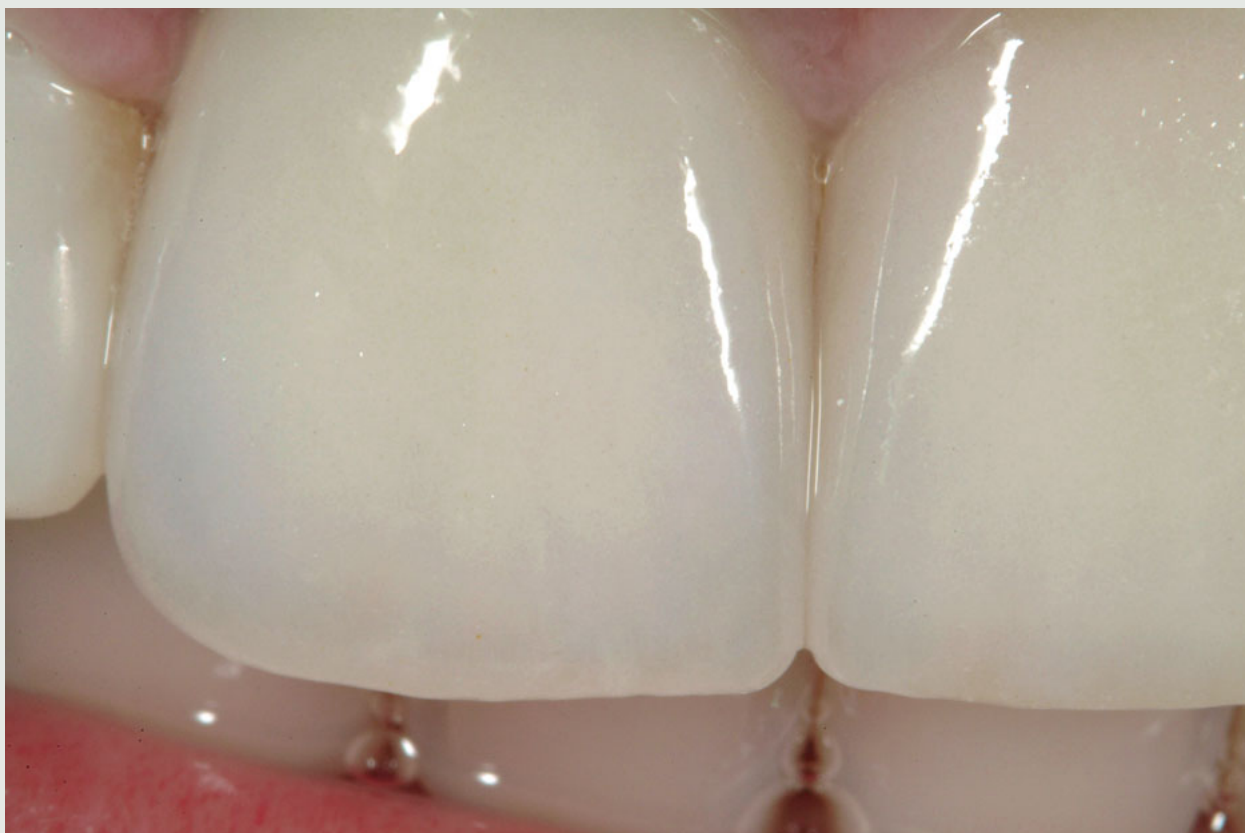
**Fig 25** Two-year postoperative detail view. Crack is still undetectable.
